Northeast Side Taildraggers

Northeast Side Taildraggers R/C Aviation Club Geotextile Runway Information

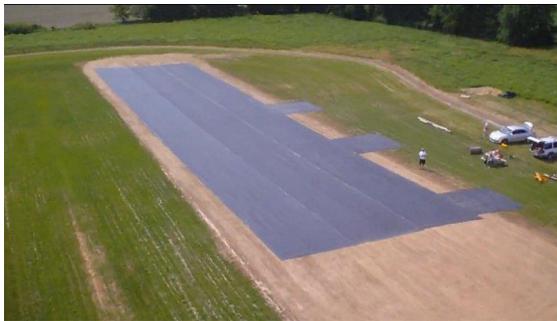
1 – Initial deployment at the school

Our first phase of deployment consisted of 3 rolls of the fabric (17.5' x 258') arranged side-by-side to yield a 52' total width. We cut 15' off of the end of each roll to use as taxi spurs along the near edge of the runway, so our initial length was about 243'. Each roll weighed in at about 250 lbs. We developed a unique and innovative process for sewing the seams; we unrolled two of the rolls of fabric, placing one roll on top of the other and lining up the edges. We built a platform on the side of a small utility trailer and mounted the sewing machine to it. With the sewing machine running off of a generator, we pulled the machine from one end of the runway to the other behind a ZTR lawn tractor while sewing the seam. It took about 3 hours to find our “groove”, then about 5 more to do both long seams and the 3 seams to connect the taxi spurs. It was two very long days.

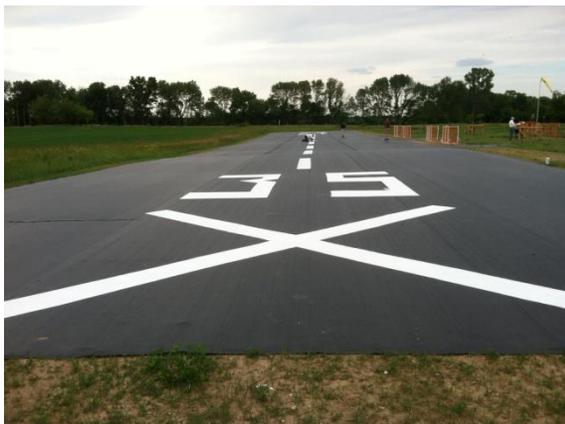
3 – Finishing up the stripes

We purchased 4 gallons of cheap "barn paint" and striped and numbered the runway. It is amazing how much that adds to the look of the site.

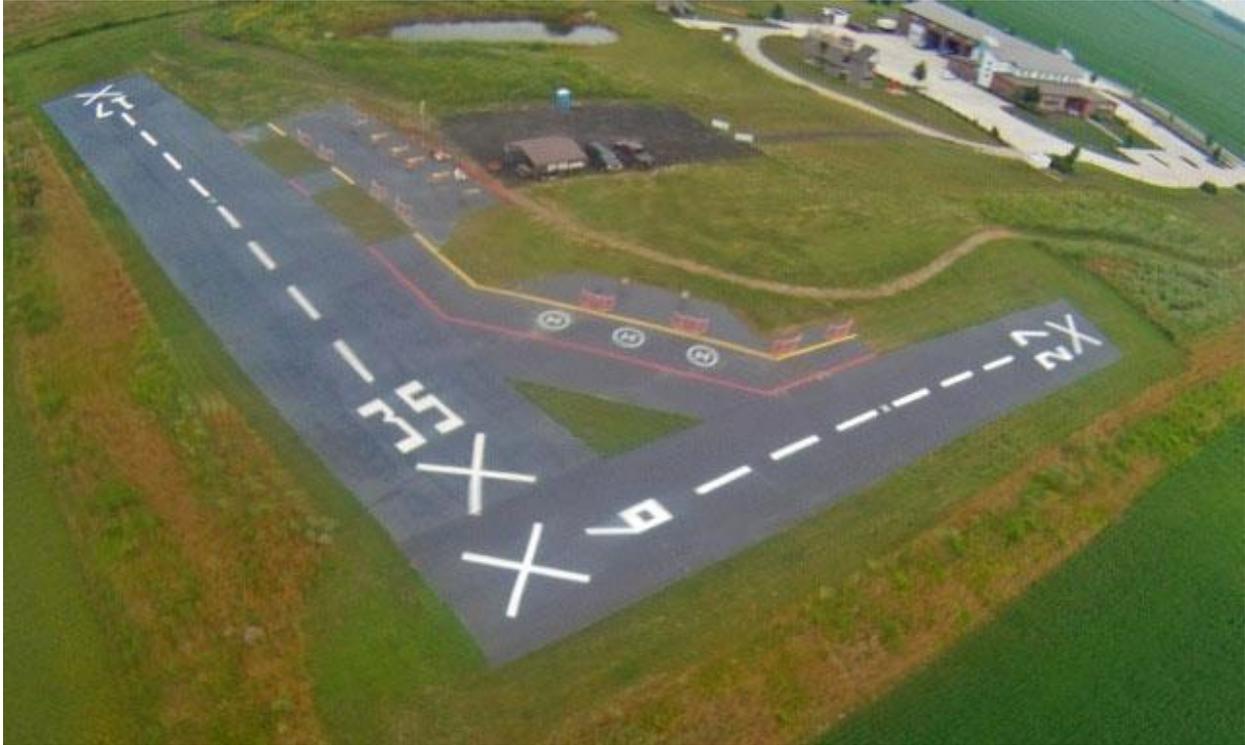
2017 Update:

Since the original writing of this article, we have added a crosswind runway, and we've used the geotextile fabric to cover our pit area and pilot station areas. All in all, I'd say we still like the fabric as a runway surface.

Because our main runway has a sloping grade that runs across the runway, we had some issues after a couple of years with erosion under the fabric. One reason for this is due to the fact that we tilled the soil to remove the large weeds and undergrowth (some of the weeds actually had bark on their trunks). Tilling loosened the soil to the point that the rain caused small ruts that grew larger with each major rainfall. We ended up pulling up the fabric and re-grading the runway, then drum-rolling it to pack it down. This didn't help, as the erosion continued. We installed French drains along the "high" side of the runway and several across the runway in an effort to eliminate the erosion. That didn't help much, either. We pulled up the fabric again, and this time we placed 6-mil plastic sheeting under the runway fabric. That seems to have eliminated the erosion problem.

For the past 2 seasons, we've had wind damage to our main runway. We've stopped using the 8" landscape staples and now we use 18" geo pins. We installed these long pins down the seams of our main runway. This seems to have corrected the wind vulnerabilities.
